North Norfolk Pathfinder project

The Pathfinder project in the UK sought to address coastal erosion issues— including decaying coastal defence structures and vulnerable residential housing— and to test adaptation strategies including a rollback scheme.

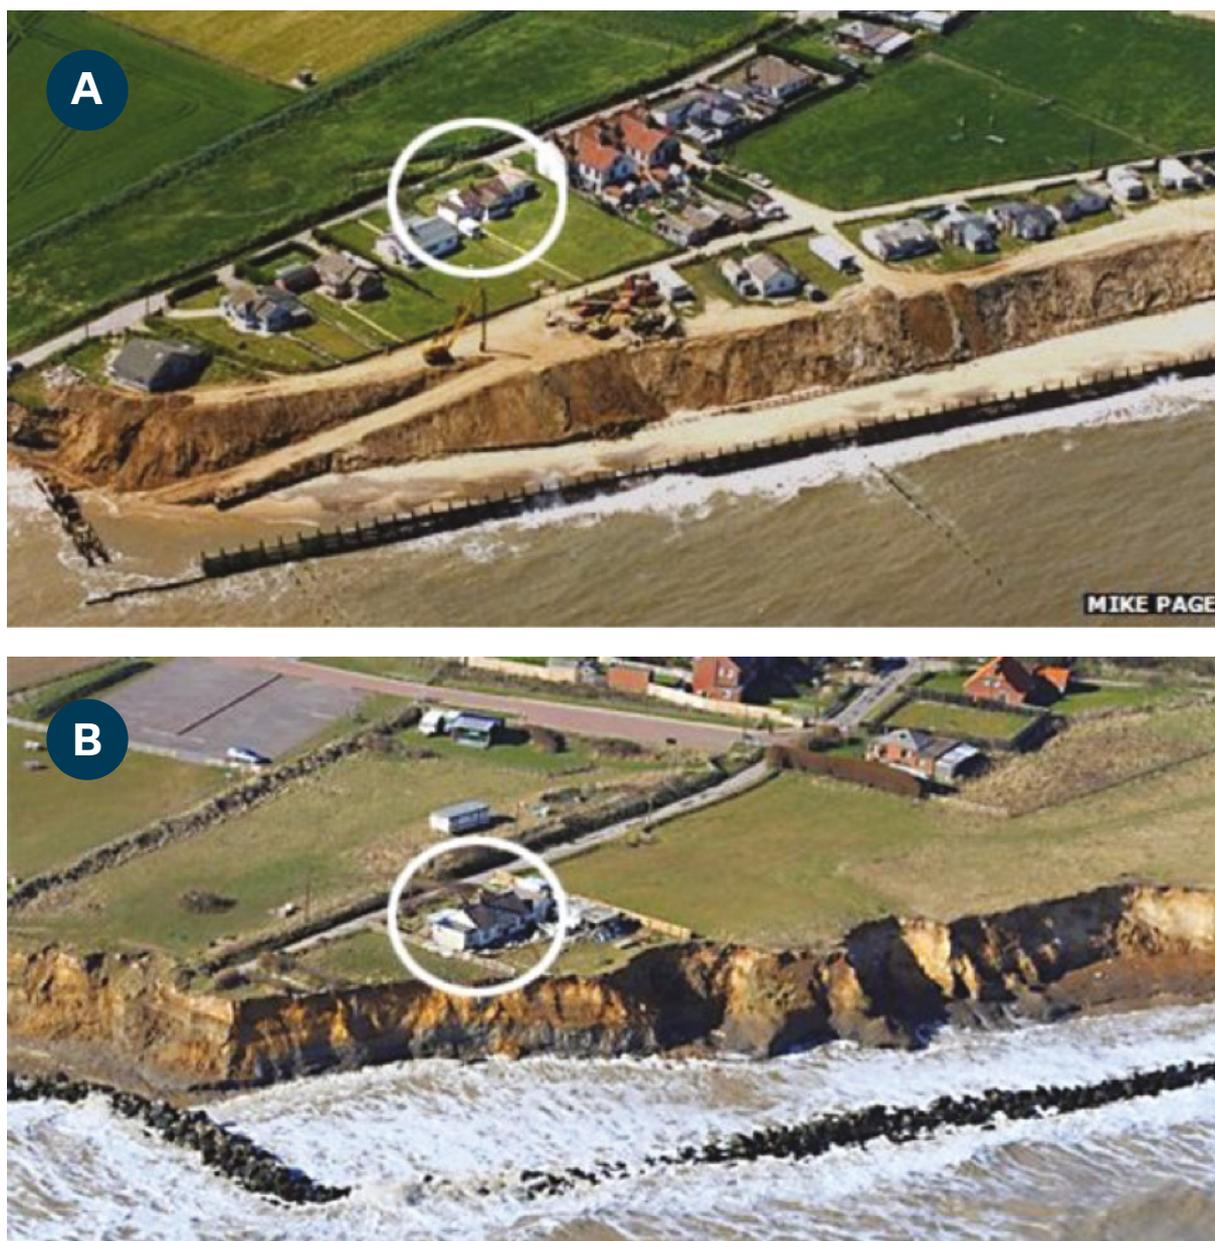
Figure 2: Photos taken in 1998 (a) and 2013 (b) at Happisburgh. Cliff erosion has left the property just metres from a sheer drop to the beach. Other houses have been demolished. Photos: © Mike Page 2016 (www.mike-page.co.uk).

Low-level coastal defences were constructed along the North Norfolk coast through the 1950s to 1970s with a design life of 20-30 years. By 2009 they were in a state of decay and there was no intention by Government to renew them. As a result, erosion of the Happisburgh cliffs is taking place at a rate of several metres per year, depending on storminess (Figure 2). Several buildings have already been lost.
