## Kingborough geotextile sandbags protect Coningham Beach

### Summary

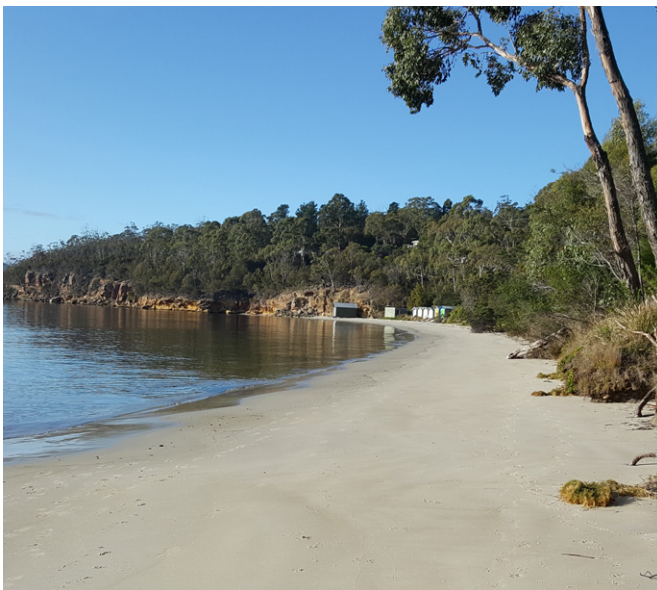
**Figure 2:** Coningham Beach. Source: © Kingborough Council, 2016.

Coningham Beach is a narrow sandy beach backed by clay and gravel sediments that are vulnerable to coastal erosion (Figure 2). Surface water runoff and beach goers' foot traffic have contributed to the appearance of large eroded notches at the back of the beach. In recent years, Coningham Beach has been impacted by significant storm events and in 2014 it was declared a high hazard erosion area.

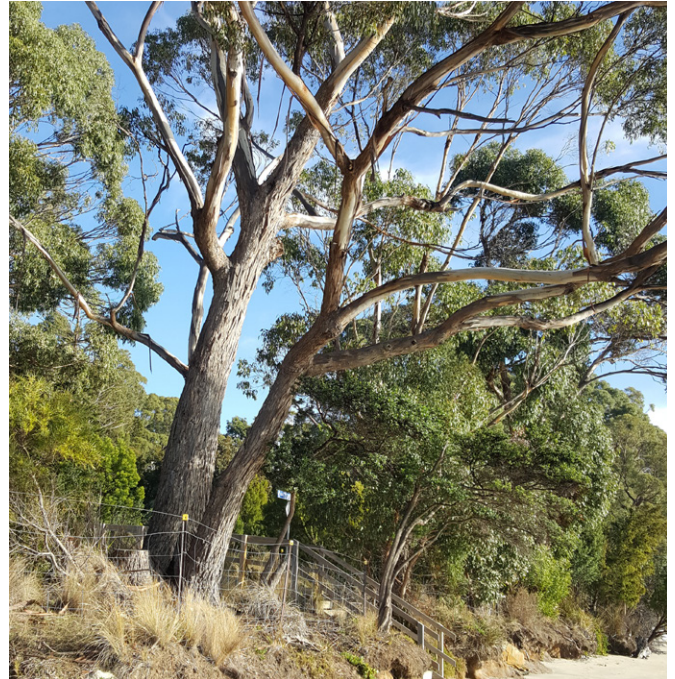
**Figure 3:** The black gums (*Eucalyptus ovata*) along Coningham Beach bank are currently under threat from coastal erosion. Large storm events are eroding the sand which supports these trees. Photo: © Climate Planning, 2016.

Behind the beach the land is made up of soft sediments which also have the potential to erode. This means the beach could move back approximately 10 metres by 2100 in response to sea-level rise. This presents an immediate risk to the black gum trees along the bank (Figure 3) and the critically endangered swift parrots (which feed exclusively on blue gums and black gums) that rely on them (Figure 4). It will also pose a longer-term risk for the car park, road and, potentially, residential dwellings.

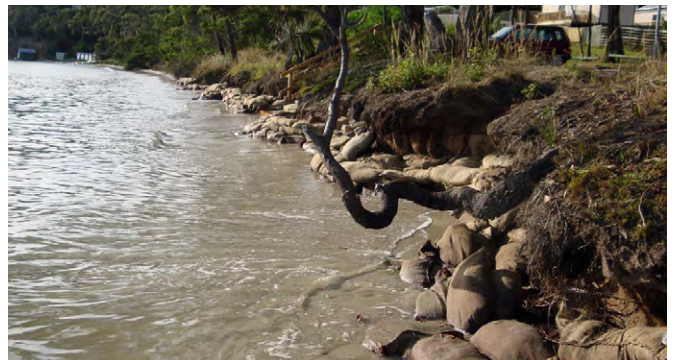
*Figure 5: Coningham Beach experienced a 'King' high tide event on the 24<sup>th</sup> of January 2011. Sandbags and replanting of coastal vegetation were used to protect the shoreline against erosion. Photo: © P. Donaldson, 2011.*

In 2012, Council upgraded the stormwater system and built a channel (or swale) behind the beach that collects, filters and reduces stormwater runoff from the car park. A subsequent project installed sandbags at the back of the beach and planted coastal species to reduce the erosive impact of wave action on the bank. The sandbags have a lifespan of 5 to 15 years, and will provide the beach with temporary protection while a longer-term coastal strategy is developed in consultation with the community (Figures 5 and 6).

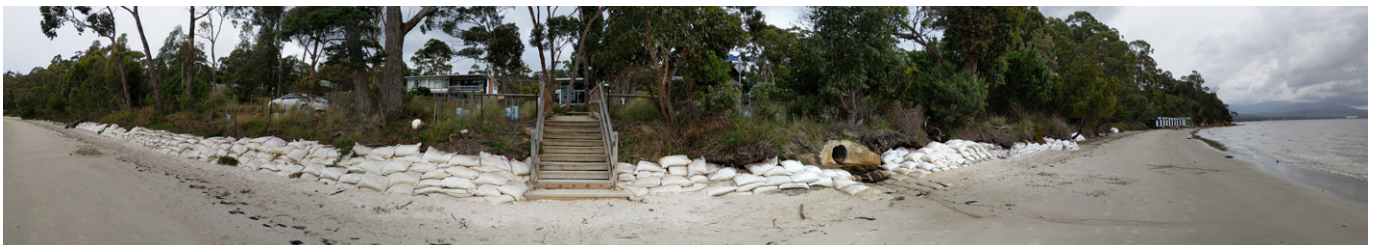
*Figure 6: Initial stages of the sandbagging project have been undertaken by Council to protect Coningham Beach from coastal erosion. Photo: © Kingborough Council, 2016.*
