# Snapshot

## New Brighton beach scraping: Byron Shire Council

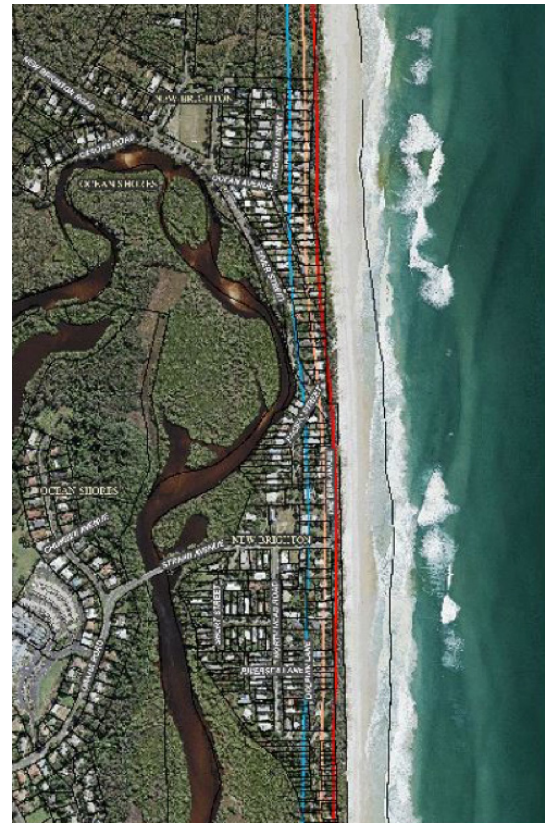
*Figure 2: Erosion hazard lines at New Brighton for the immediate (red), 2050 (beige) and 2100 (blue) timeframes. Source: © Patterson 2013.*

Recent studies have predicted that a large 'design' storm (i.e. a storm with a 100 year average occurrence interval) could result in the erosion of the beach at New Brighton by 40 m to 50 m landward, or 200 m<sup>3</sup>/m (Patterson 2013). As a consequence, parts of the main public road and infrastructure at New Brighton are under immediate threat from an extreme storm, or series of very large storms, which could occur at any time. New Brighton beach is also experiencing underlying long-term shoreline recession due to an imbalance in the sediment budget, with more sediment leaving the system than is being returned. This long-term recession has been estimated at 8 to 15 cm/year.

The risk to New Brighton beach from projected climate change-induced sea-level rise is also very significant when looking into the future. The vulnerability of this area of the coast to beach erosion and shoreline recession increases with time, and most of the seaward properties and road infrastructure in New Brighton are projected to be at risk from, or impacted by, coastal recession by the year 2050 (see Figure 2). Wave over-topping to the hind-dune areas also presents a significant inundation hazard along the beach where the dune area is narrow and/or low.

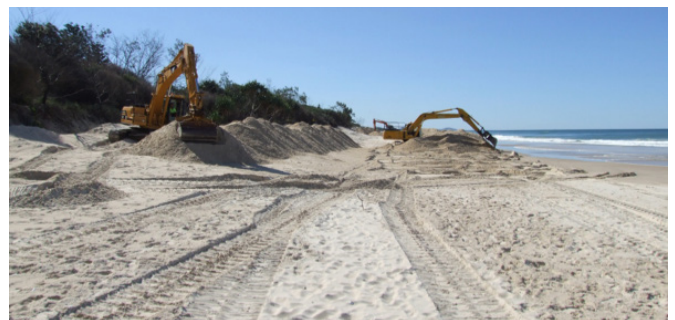
*Figure 3: Machinery at work during beach scraping. Source: © Byron Shire Council 2013.*

Past response to the threat of erosion at New Brighton has included the practice of beach scraping. Beach scraping is the mechanical movement of sand from the intertidal zone and placement of this sand onto the dune area. The practice is designed to speed up the rebuilding of the dune system after a storm event. It can also be used to assist in the reshaping and rebuilding of a dune system at any other time to protect coastal lands from coastal erosion, underlying shoreline recession, wave overtopping and inundation (see Figure 3).

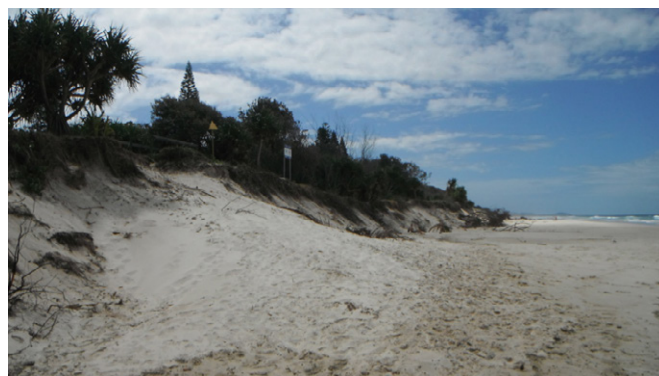
*Figure 4: New Brighton beach before beach scraping works in 2013. Source: © Byron Shire Council 2013.*

The 2010 trial program was considered a success from an environmental, technical and social perspective, and the Council resolved to implement an on-going beach scraping program subject to funding and the prevailing coastal processes at the time. A successful trial was undertaken in 2013: before and after photos highlight the increased beach width and dune volume (see Figures 4 and 5).

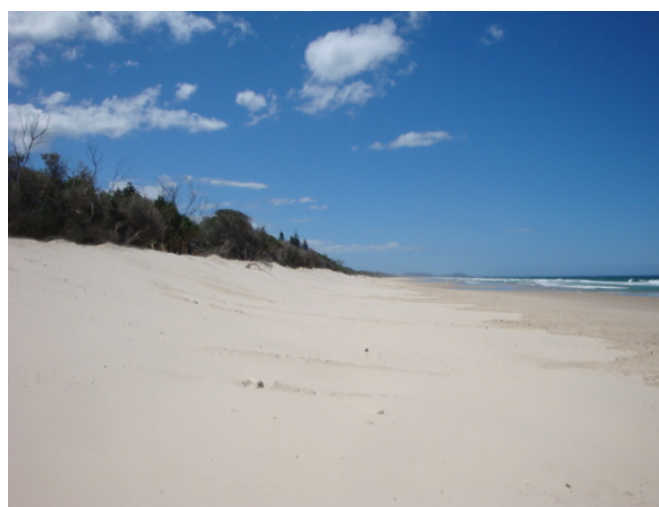
*Figure 5: New Brighton beach after beach scraping works in 2013. Source: © Byron Shire Council 2013.*
